## **Milestone Inspection – Phase 2**

# **Bayshore Trace Condominium Association**

3325 Bayshore Blvd, Tampa, Florida 33629

**March 25, 2024**

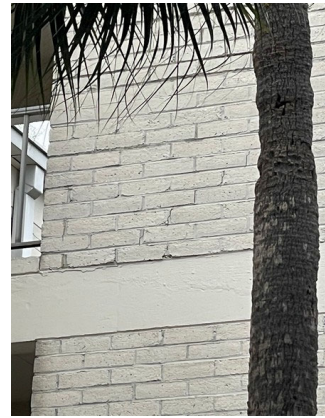
4 stairwell A step cracking in brick

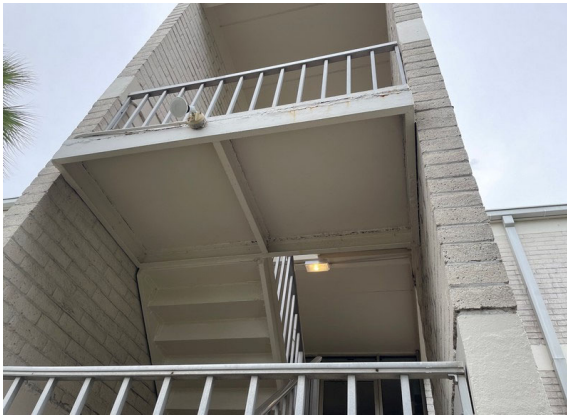
Stairwell A, B, E, F, and Interior were all visually inspected. Extreme corrosion has occurred and damaged the top plate of the steel I beams that support the concrete landings. Steel risers also show signs of corrosion, although it is not as extreme as the I beams. Stairwell A, B, E, F and interior should all have the Steel I beam replaced on the lower level. Stairwell A, B, E and F should also have the second level I beams replaced. Any brick that has been damaged from corrosion should be repaired. The landing is a reinforced concrete slab and is in good condition.

5 stairwell A corrosion

The next steps for this association is to replace all the stairwells I beams. The association needs to proceed with repairs within 365 days. Beryl will assist in developing permit ready repair plans and construction documents if the association wants to move forward with us as the engineering firm for these next steps.

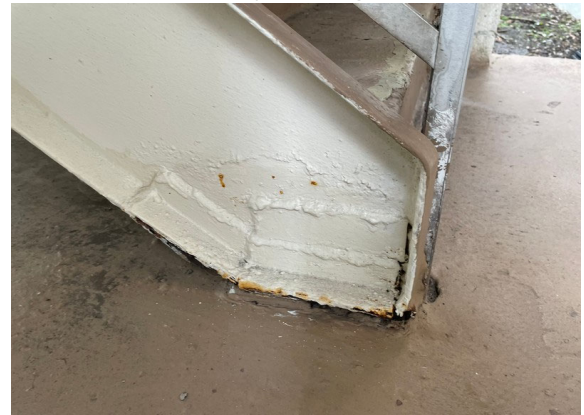
6 stairwell A corrosion

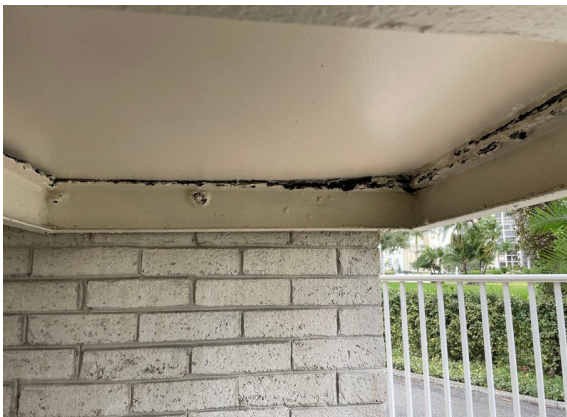
7 stairwell A corrosion

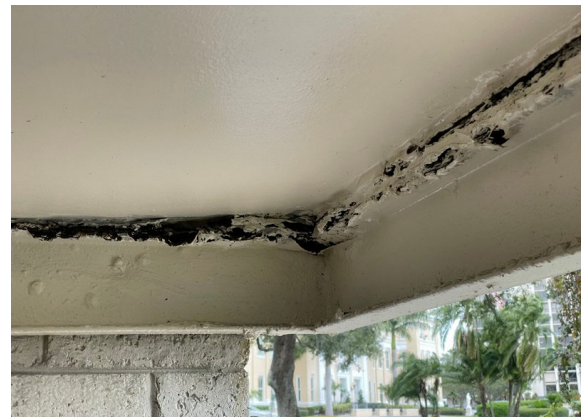
8 stairwell A corrosion

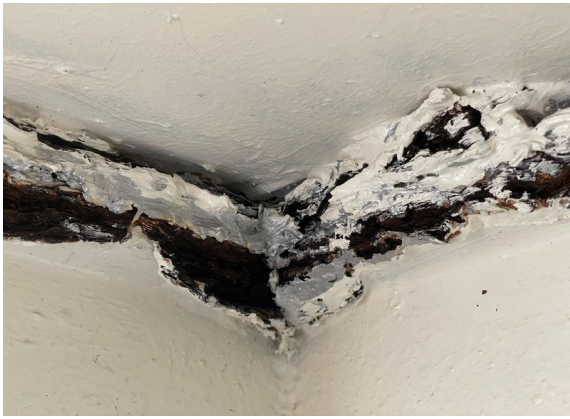
9 stairwell A corrosion

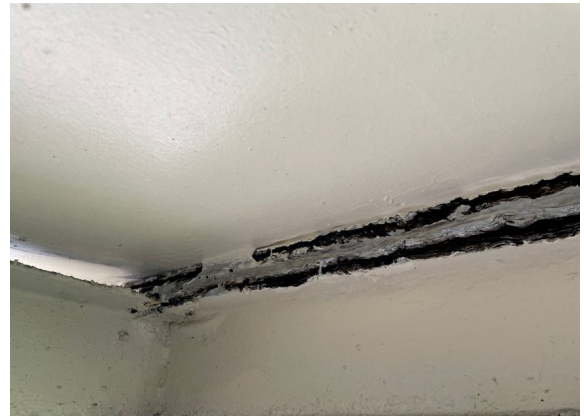
10 stairwell A corrosion

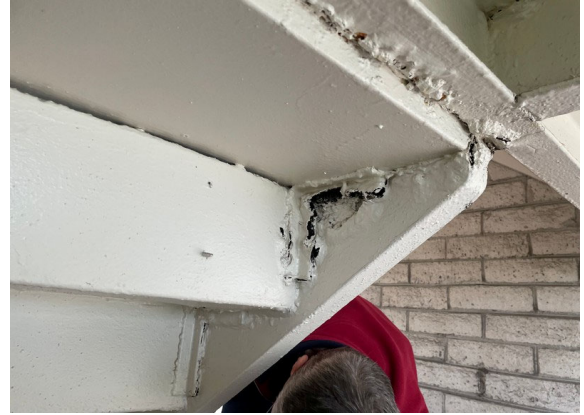
12 stairwell A corrosion

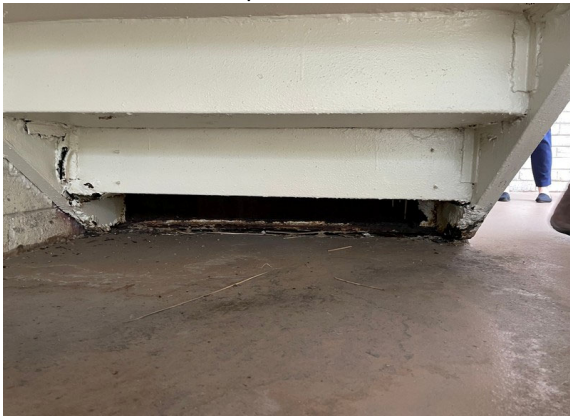
13 stairwell A corrosion

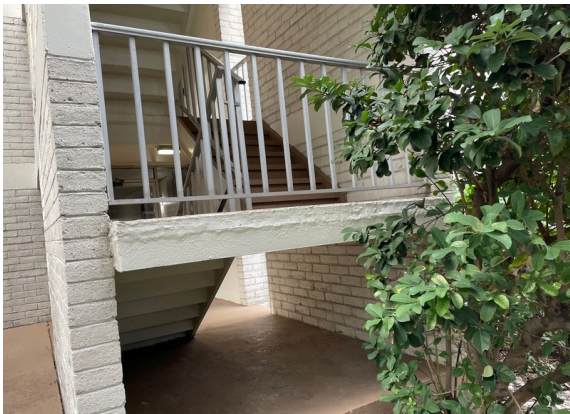
15 stairwell B corrosion

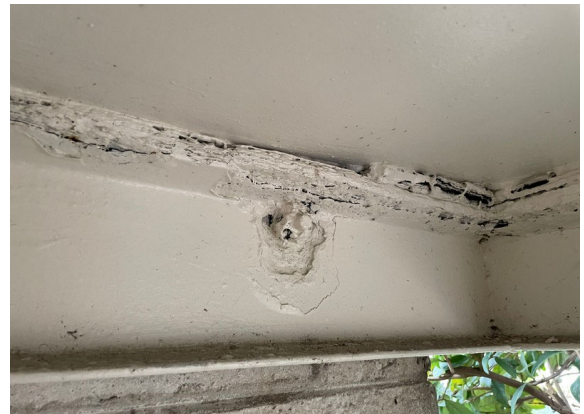
16 stairwell B corrosion

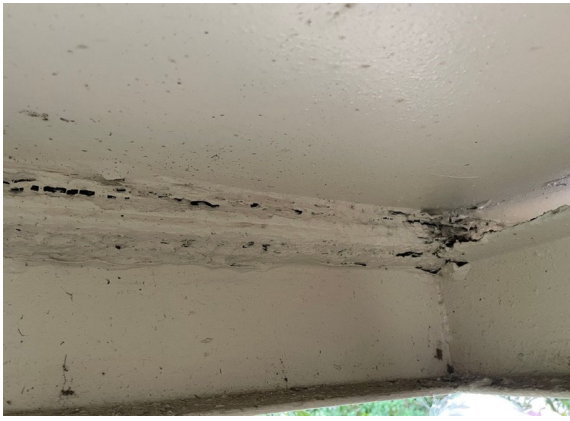
17 stairwell B corrosion

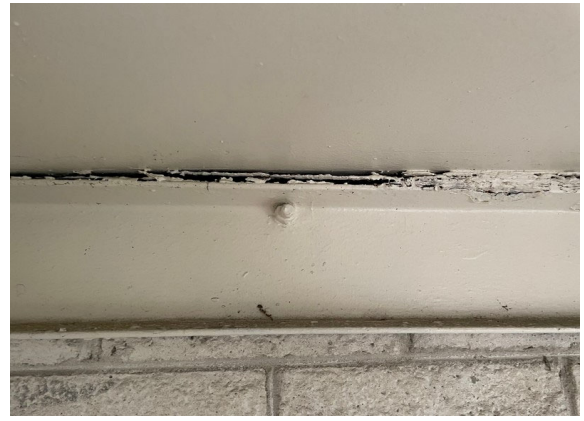
18 stairwell B corrosion

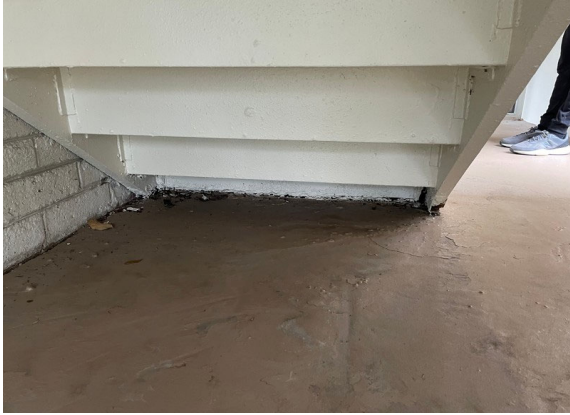
19 stairwell B corrosion

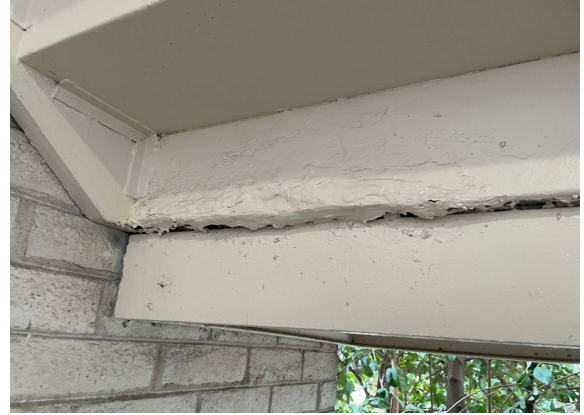
20 stairwell B corrosion

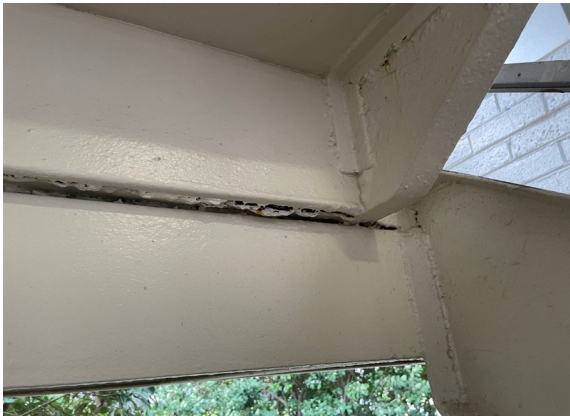
21 stairwell B corrosion

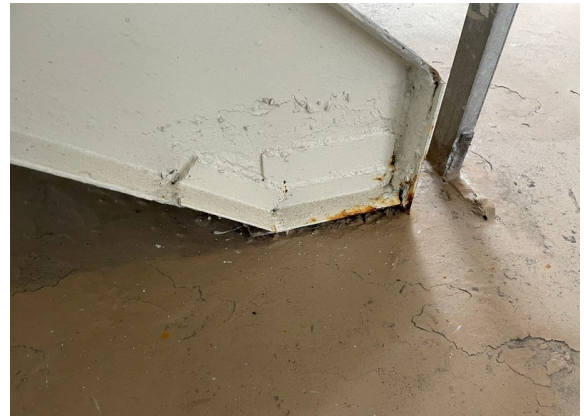
22 stairwell B corrosion

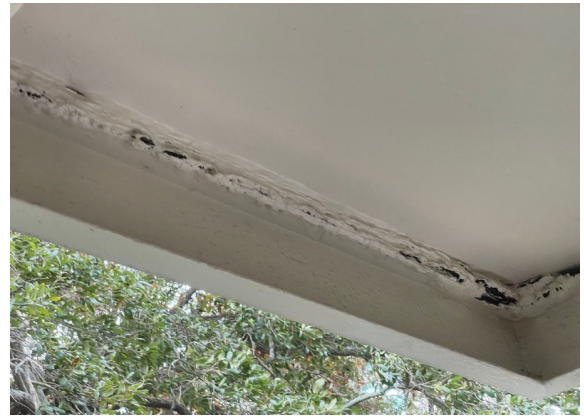
26 stairwell B corrosion

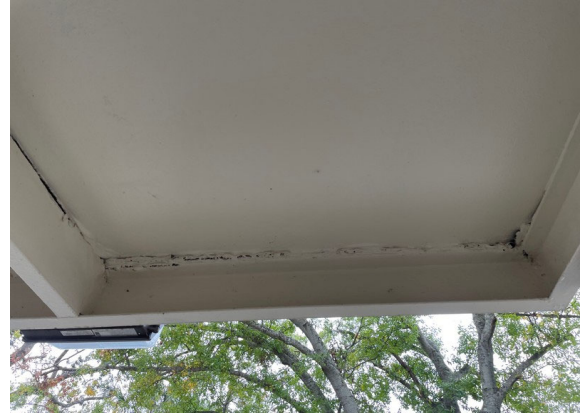
28 stairwell E corrosion

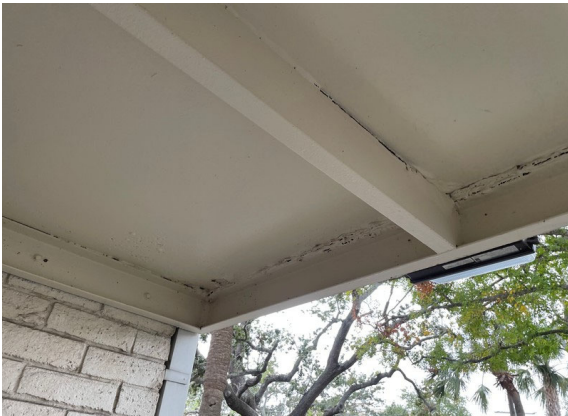
29 stairwell E corrosion

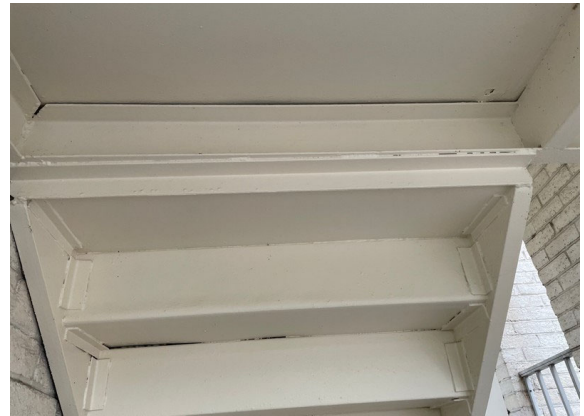
30 stairwell E corrosion

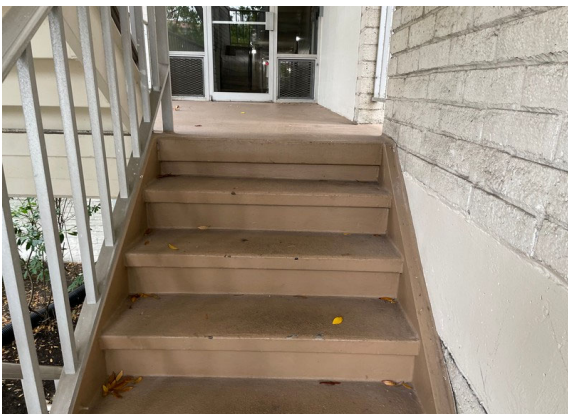
31 stairwell E corrosion

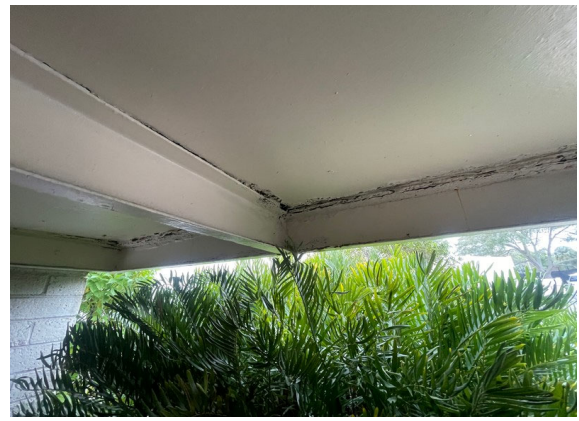
34 stairwell F corrosion

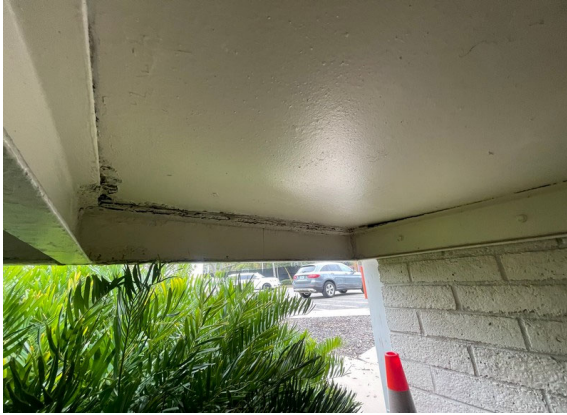
35 stairwell F corrosion

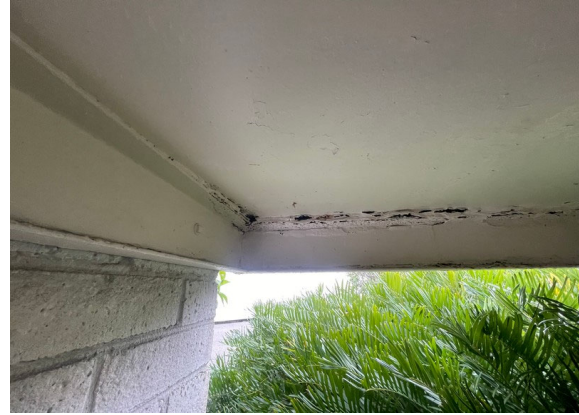
36 stairwell F corrosion

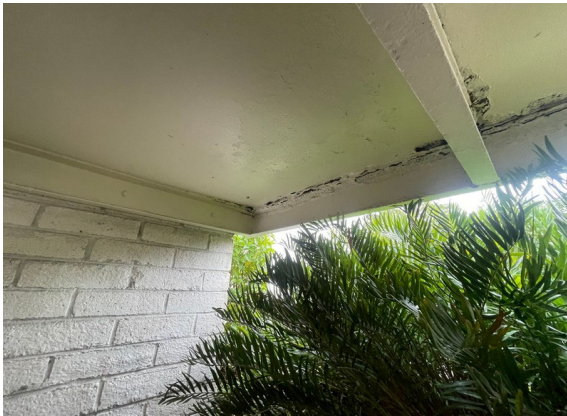
37 stairwell F corrosion

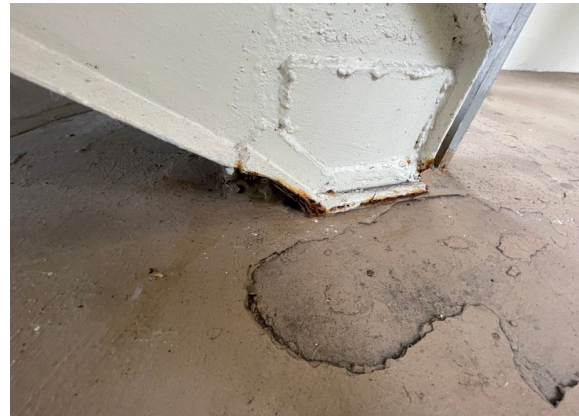
38 stairwell F corrosion

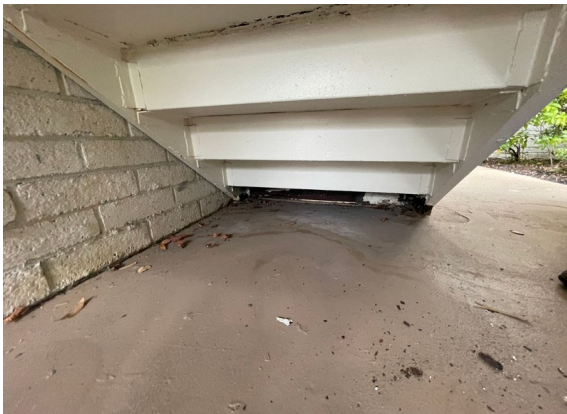
39 stairwell F corrosion

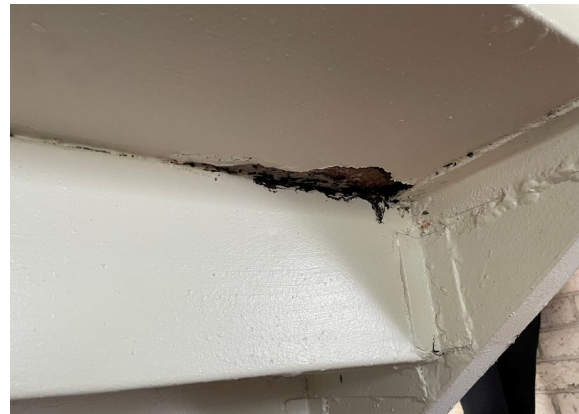
40 stairwell F corrosion

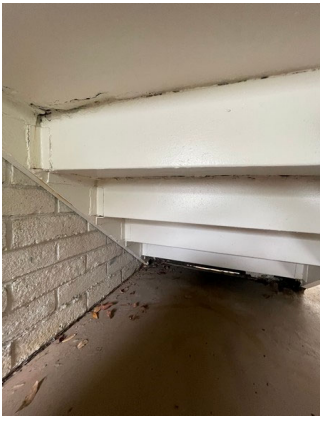
41 stairwell F corrosion

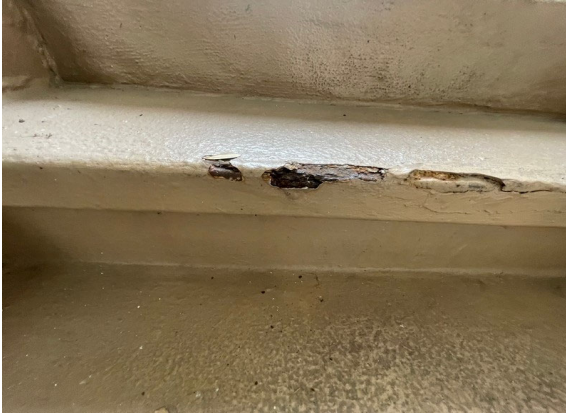
43 stairwell F step corrosion

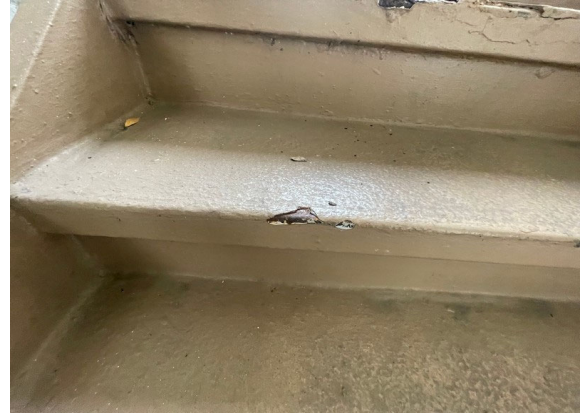
44 stairwell F step corrosion

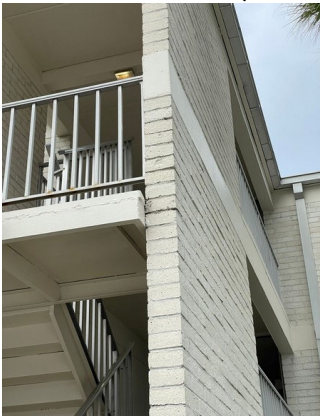
45 stairwell F connection corrosion damaging brick

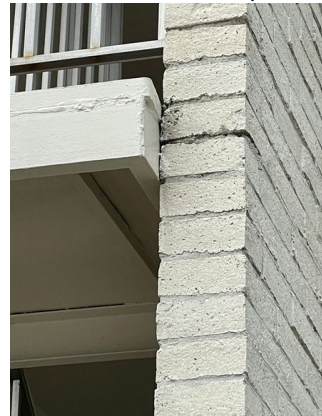
46 stairwell F connection corrosion damaging brick

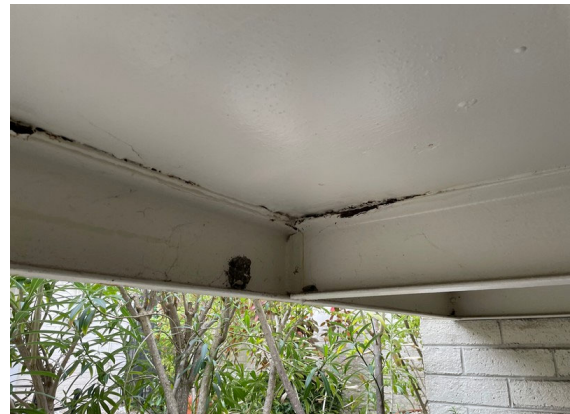
48 Interior stairs corrosion

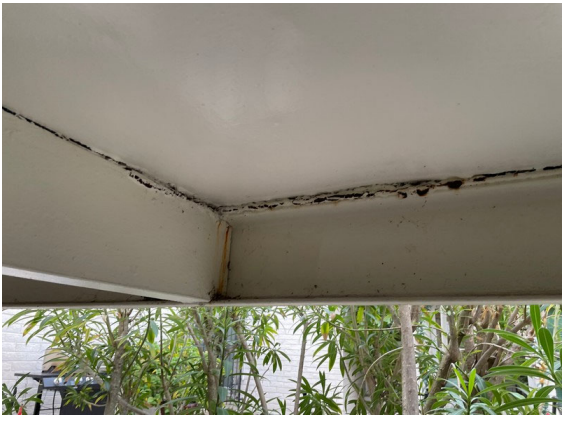
49 Interior stairs corrosion

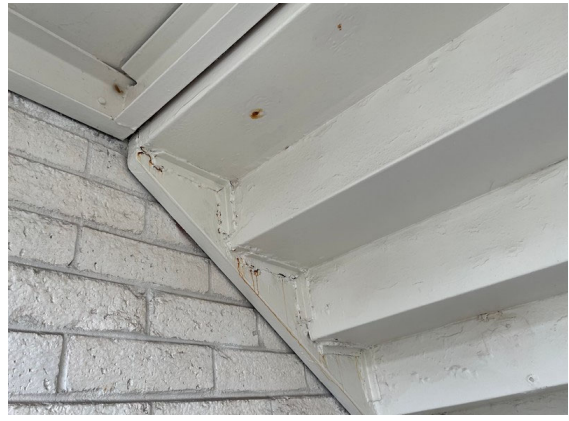
50 Interior stairs corrosion
