To: Bayshore Trace COA
From: Leo Cannyn, PMP, P.E., Principal Project Manager
Subject: 3325 Bayshore Blvd, Tampa, FL 33629 Engineering Affidavit for Milestone Inspection Phase 1
Date: 8/31/2023

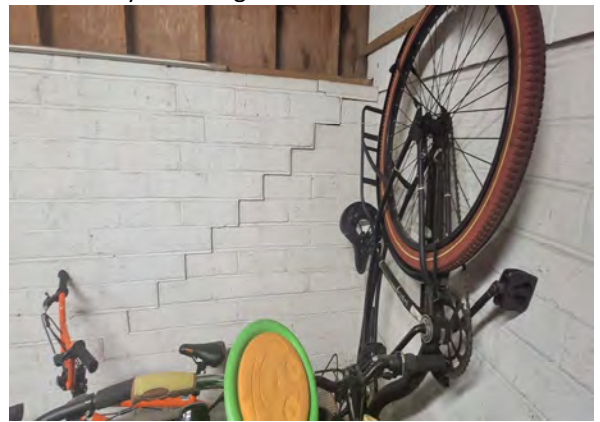
46 Differential Step Cracking Bicycle Storage

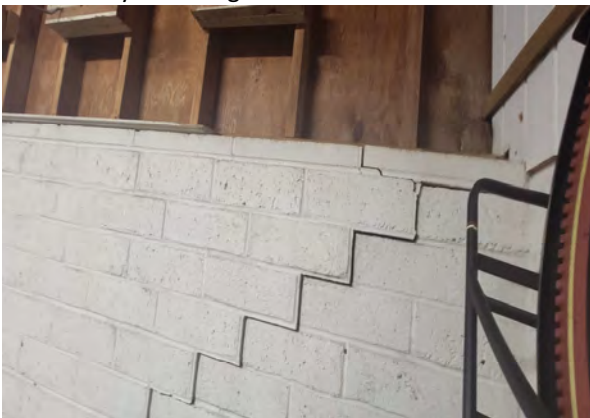
47 Differential Step Cracking Bicycle Storage

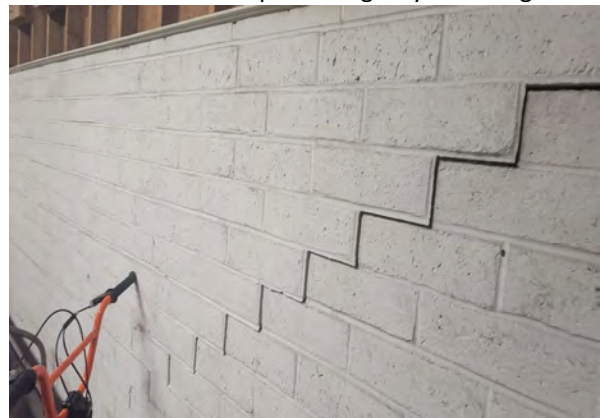
48 Differential Step Cracking Bicycle Storage

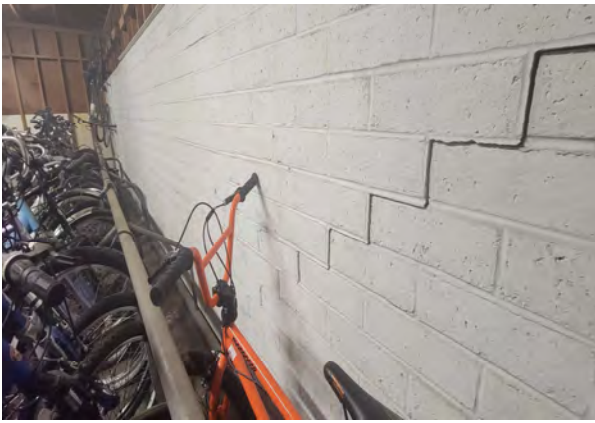
49 Differential Step Cracking Bicycle Storage

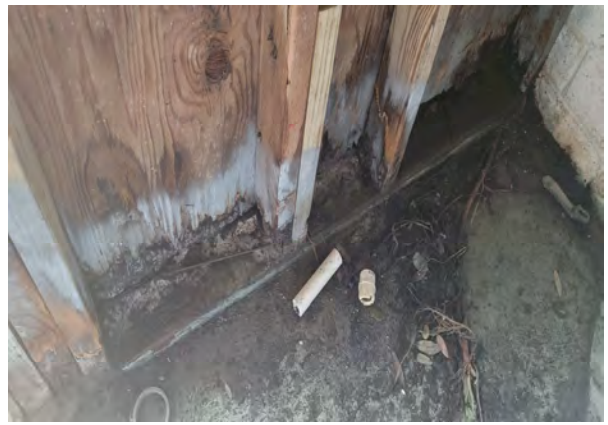
58 Water Damage/Organic Growth Pool Pump Room

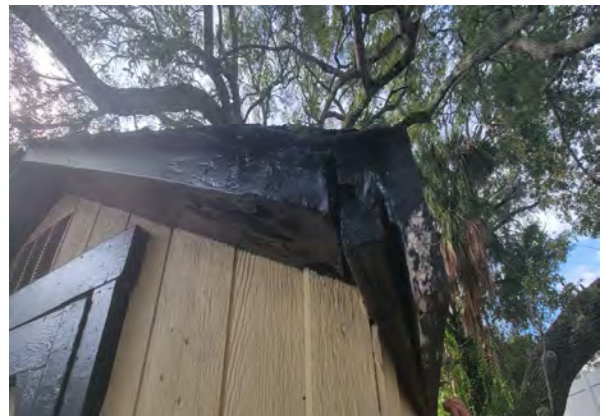
64 Tool Shed Water Damage

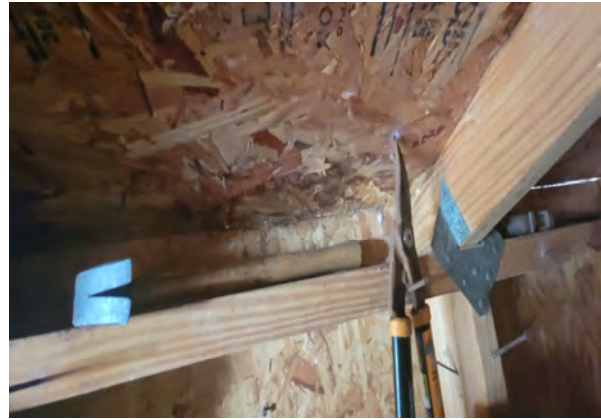
68 Tool Shed Water Penetration

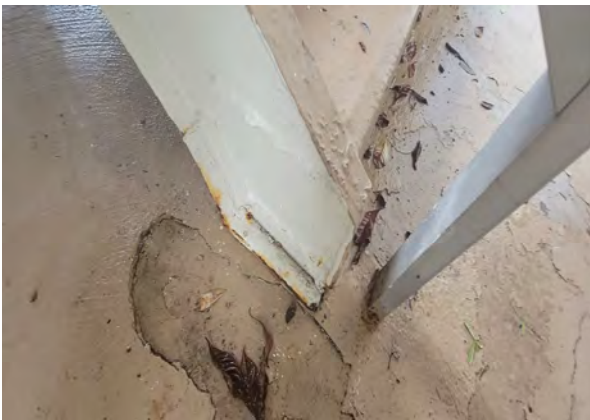
- The exterior stairs in the F hallway have significant rust to the stringers and below the landing. Beryl recommends having engineered drawings rendered for the affected staircase and being repaired by licensed tradesmen following the Florida Building Code.
- The exterior stairs in the E hallway rust was found on structural members. Beryl recommends having engineered drawings rendered for the affected staircase and being repaired by licensed tradesmen following the Florida Building Code.
- The exterior stairs in the A hallway have rust and loose spindles to and on structural members. Beryl recommends having engineered drawings rendered for the affected staircase and being repaired by licensed tradesmen following the Florida Building Code.

69 Hallway F Rust at Stairs

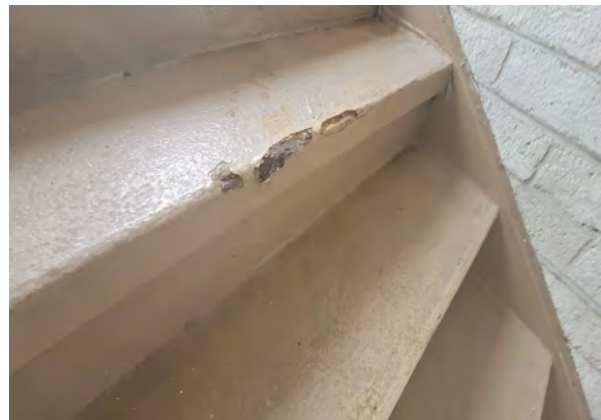
70 Hallway F Rust at Stairs

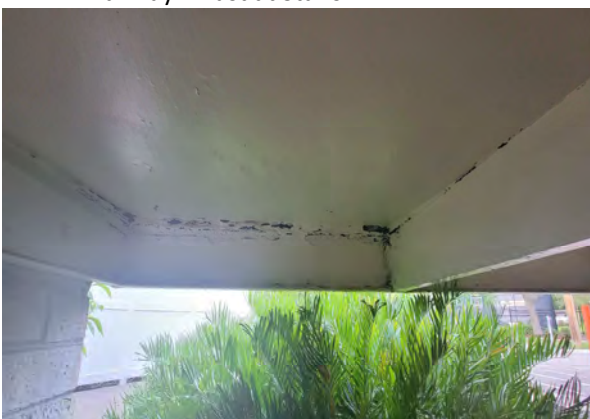
71 Hallway F Rust at Stairs

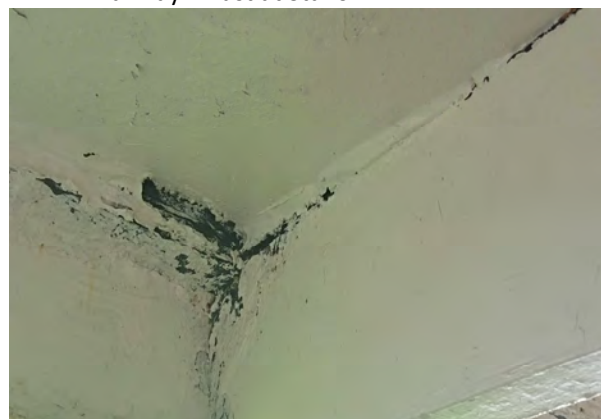
72 Hallway F Rust at Stairs

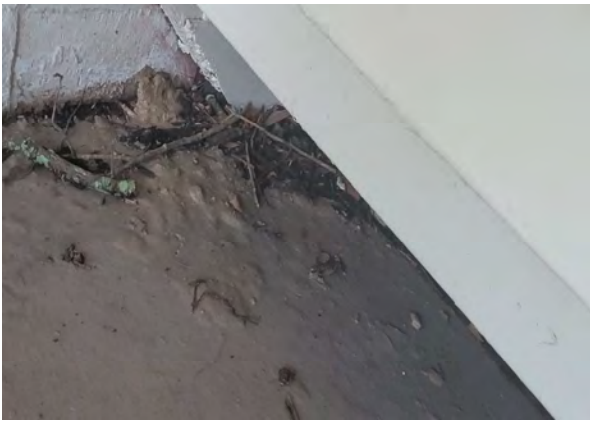
73 Hallway F Rust at Stairs

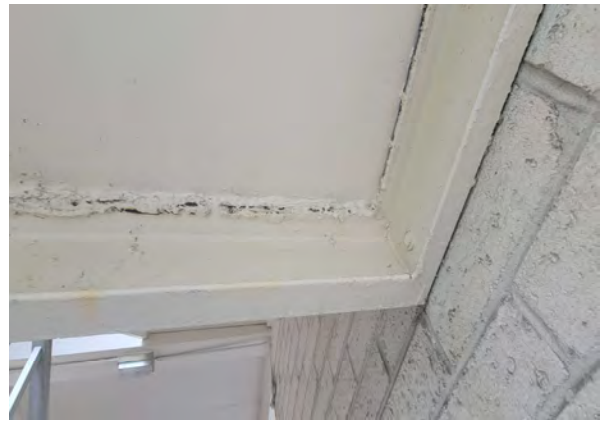
74 Hallway E Rust at Stairs

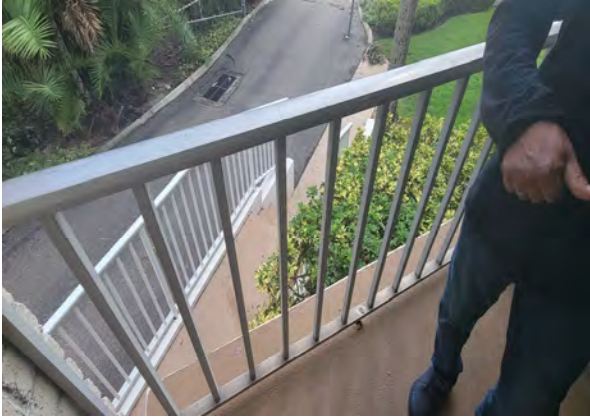
75 Hallway A Stairs Loose Spindles and Rust

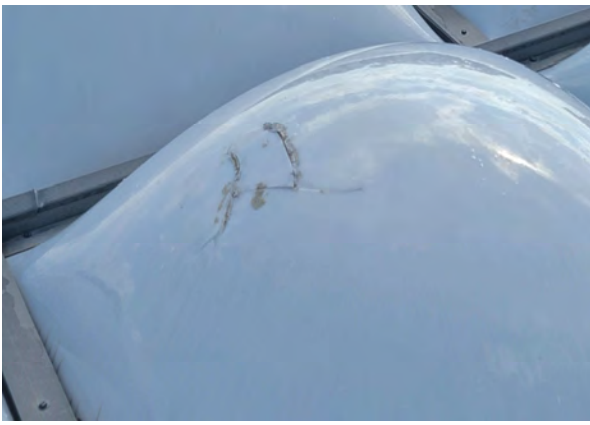
- In Unit C-27 the rail cap was loose and no longer secured. Beryl recommends properly securing the affected rail cap.
- There were multiple cracks in the skylights on the roof. Beryl recommends the repair or replacement of all skylights.
- The exterior stairs in the B hallway rust was found on structural members. Beryl recommends having engineered drawings rendered for the affected staircase and being repaired by licensed tradesmen following the Florida Building Code.
- In unit D-32 the small section of railing on the right side of the balcony was loose. Beryl recommends properly securing the affected railing.

80 Cracks in Skylight

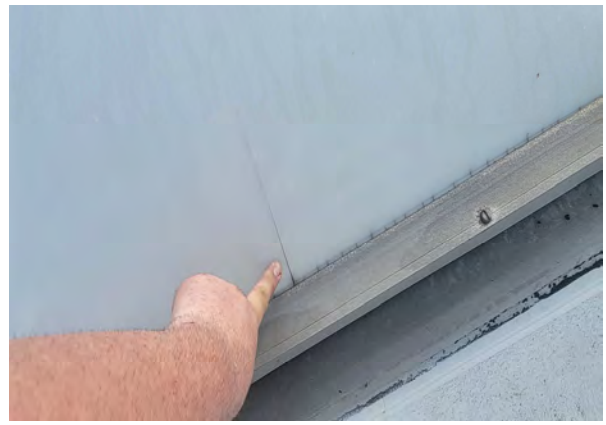
81 Cracks in Skylight

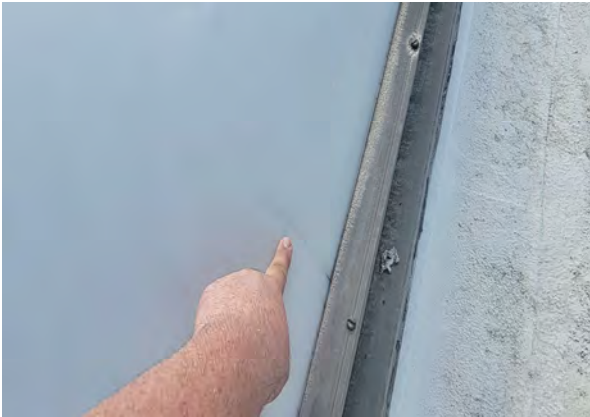
82 Cracks in Skylight

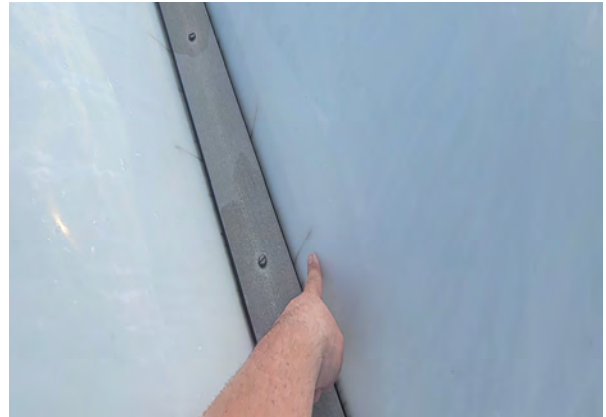
83 Cracks in Skylight

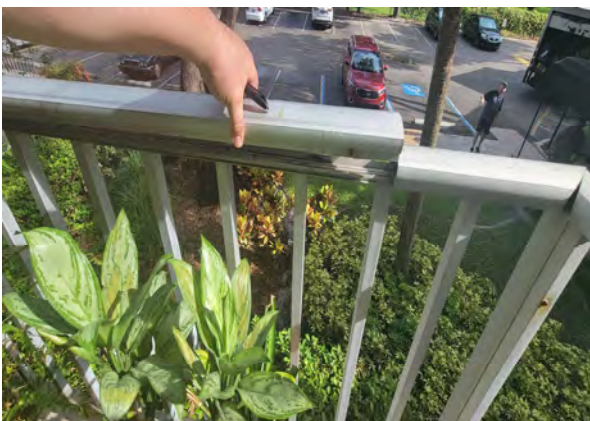
86 Loose Rail Cap

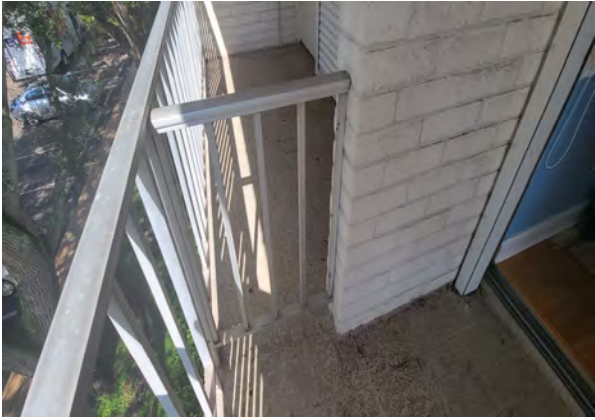
88 Loose Railing
