To: Bayshore Trace COA
From: Leo Cannyn, PMP, P.E., Principal Project Manager
Subject: 3325 Bayshore Blvd, Tampa, FL 33629 Engineering Affidavit for Milestone Inspection Phase 1
Date: 8/31/2023

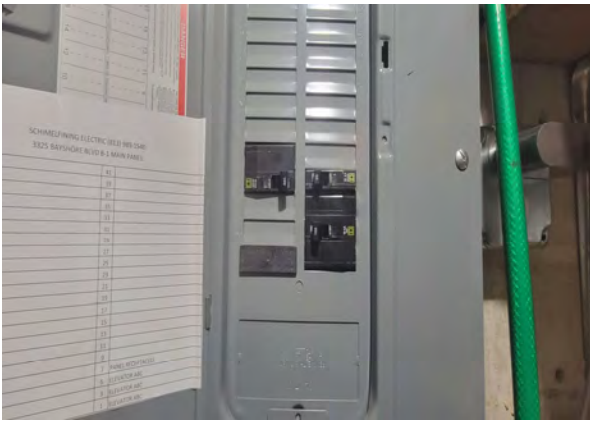
40 Chemical Storage Electrical Panel

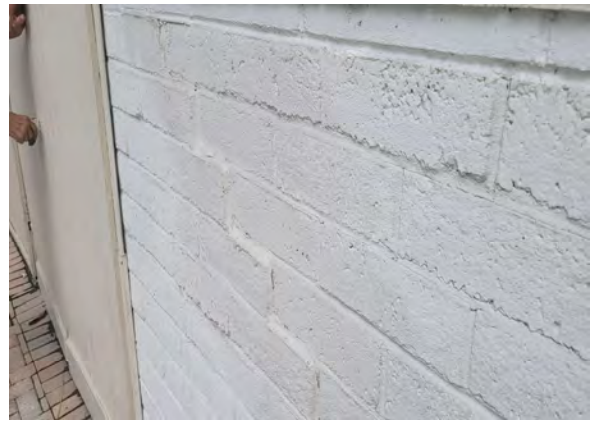
49 Differential Step Cracking Bicycle Storage

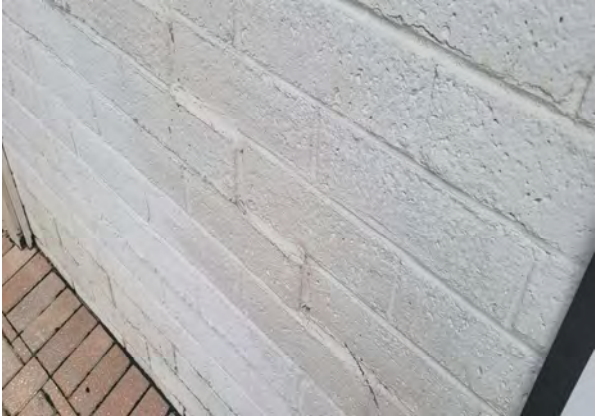
50 Exterior Side of Bicycle Storage Room Wall

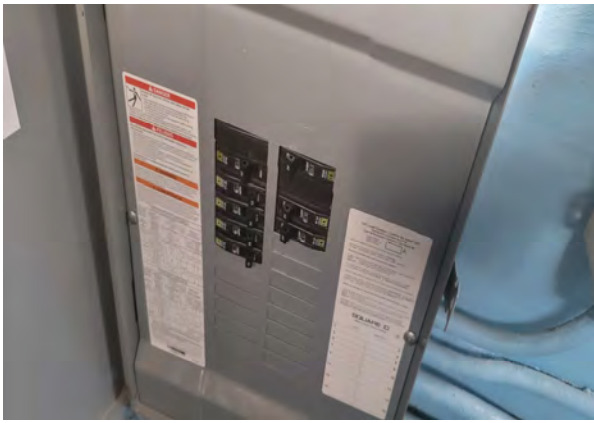
56 Pool Pump/Plumbing

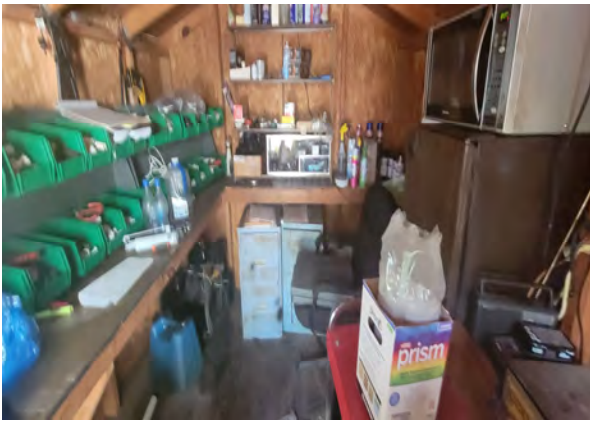
64 Tool Shed Water Damage

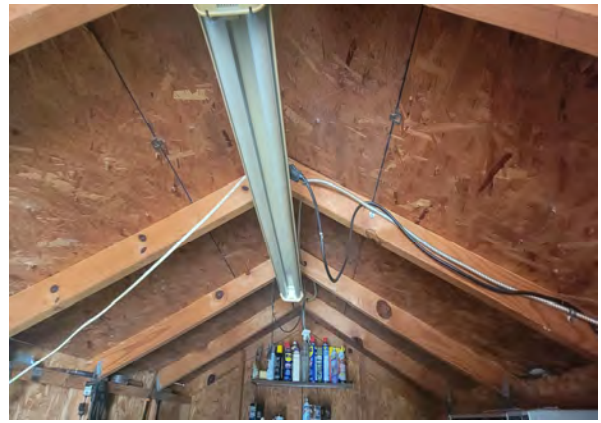
65 Tool Shed Interior

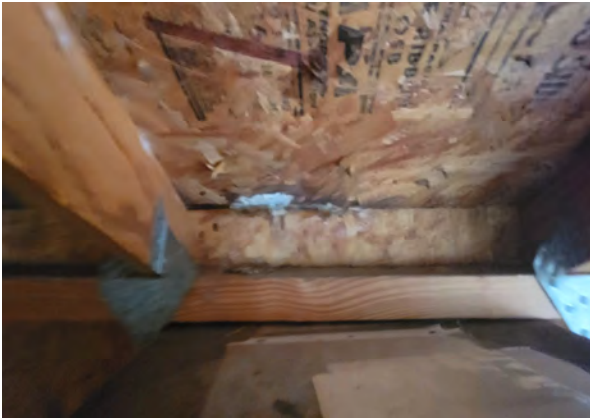
66 Tool Shed Roof Framing
