To: Bayshore Trace COA
From: Leo Cannyn, PMP, P.E., Principal Project Manager
Subject: 3325 Bayshore Blvd, Tampa, FL 33629 Engineering Affidavit for Milestone Inspection Phase 1
Date: 8/31/2023

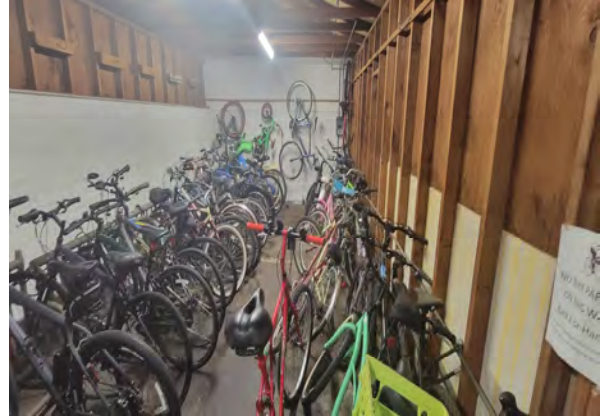
43 Bicycle Storgae

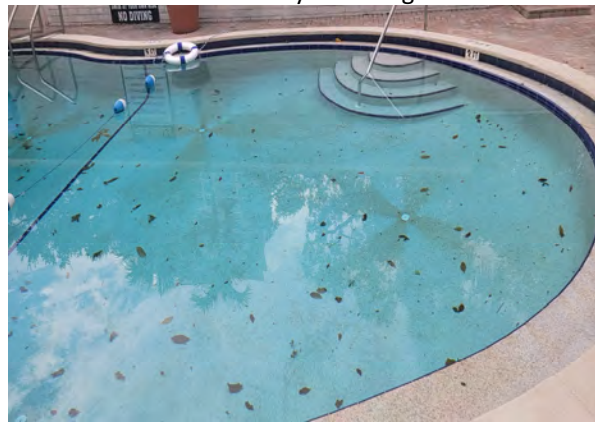
52 Pool Overview

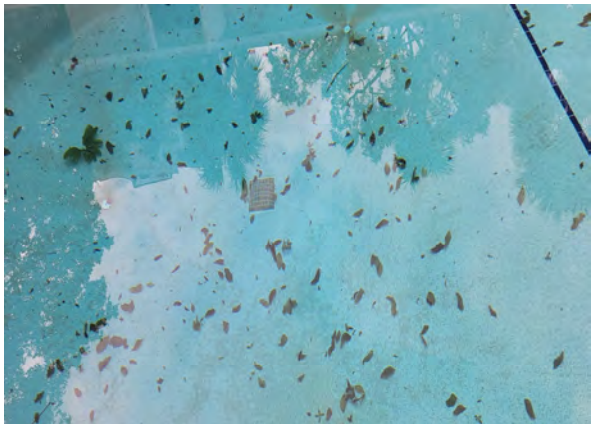
53 Pool Overview

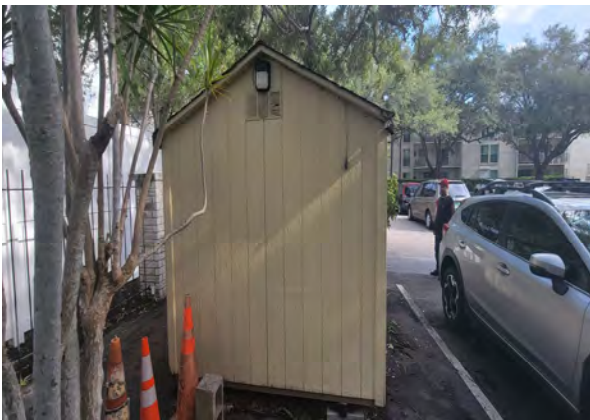
60 Tool Shed Right

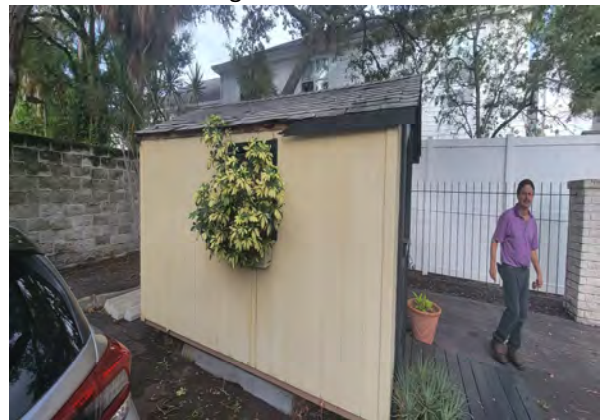
61 Tool Shed Rear

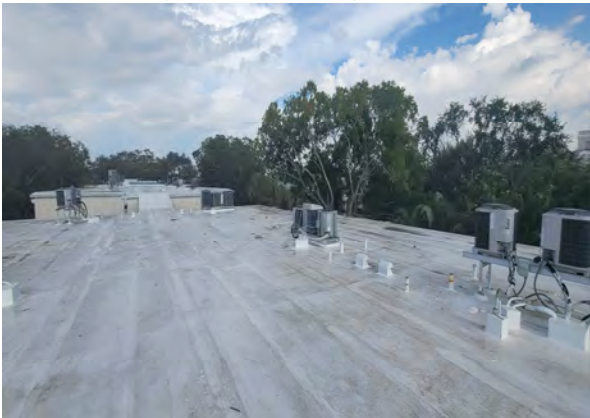
76 Roof Overview

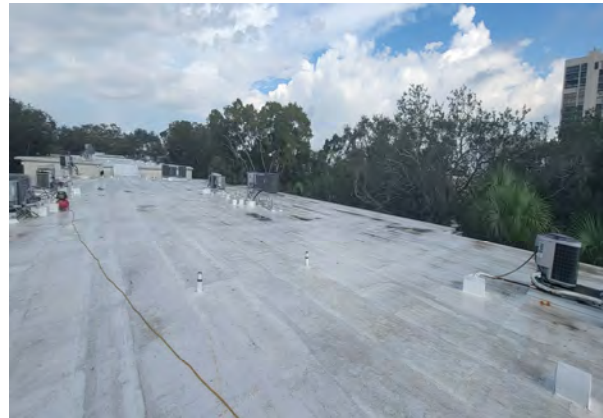
77 Roof Overview

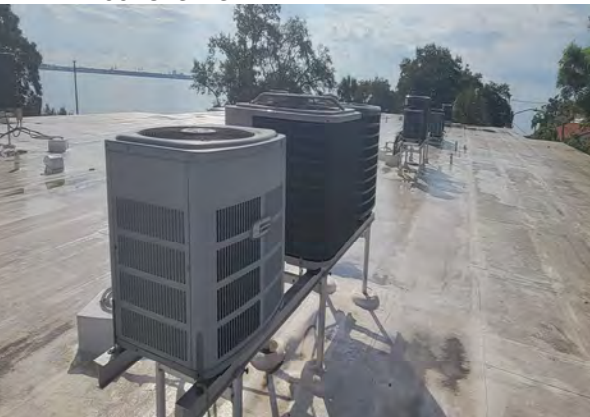
78 Roof Overview

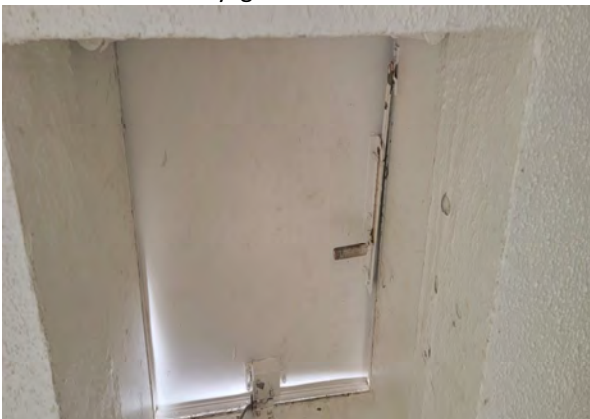
83 Cracks in Skylight
